Mission Impossible- Advanced Methods for Steep Slopes

ADVANCED SUSTAINABLE EROSION CONTROL

CTSW-OT-11-255.13.1.D9

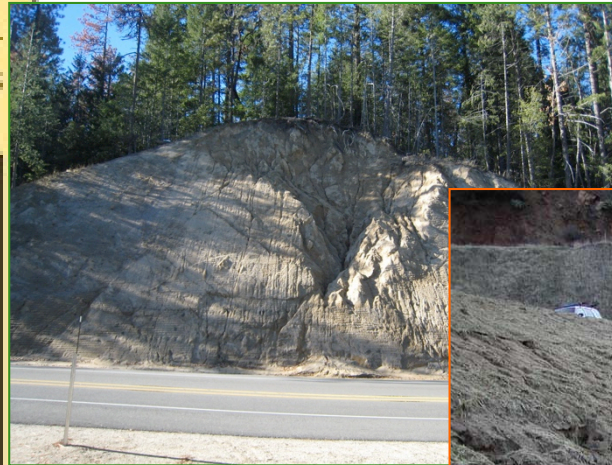
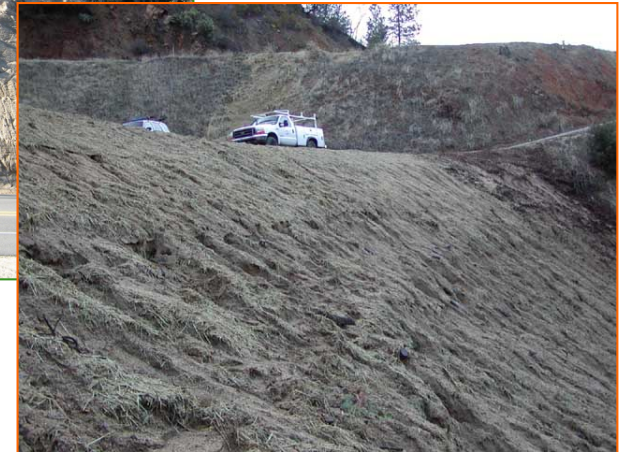
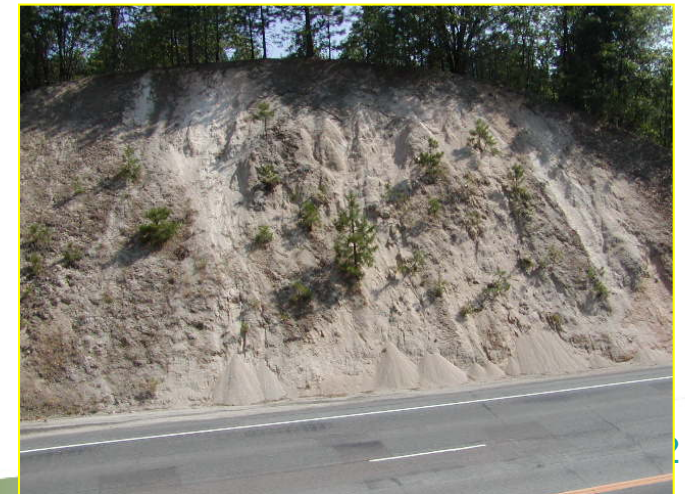
Common slope problems associated with Roads *

Figure 5.55 - Common landslides typically associated with road construction. Modified after Varnes (1978) and Bedrossiand (1983).

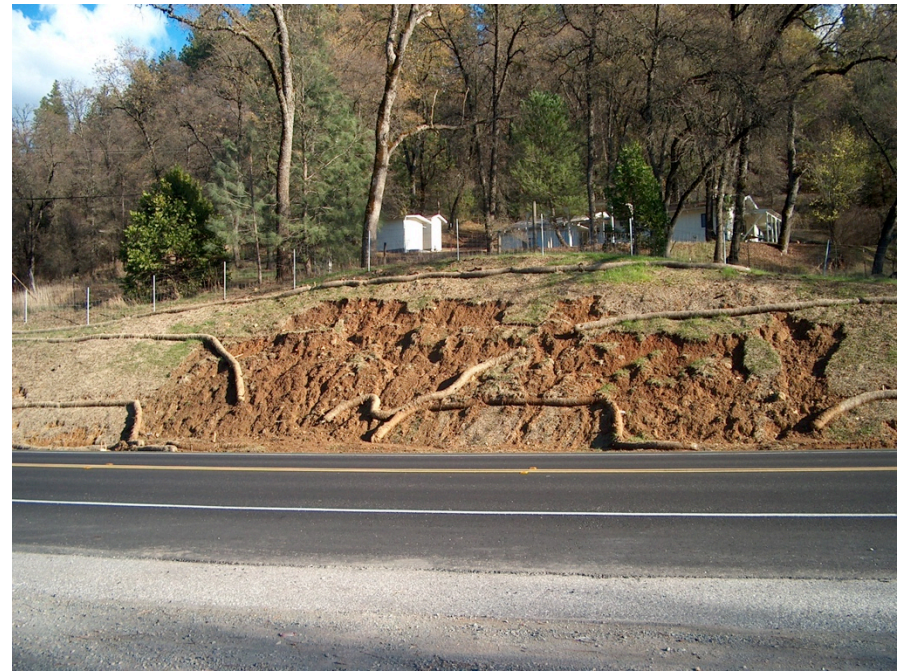
Site challenges

New constructed short cut slope 1.25:1 after first heavy rains. There was some grass growing prior to shallow failure. Not track walked, outer slope was loose.

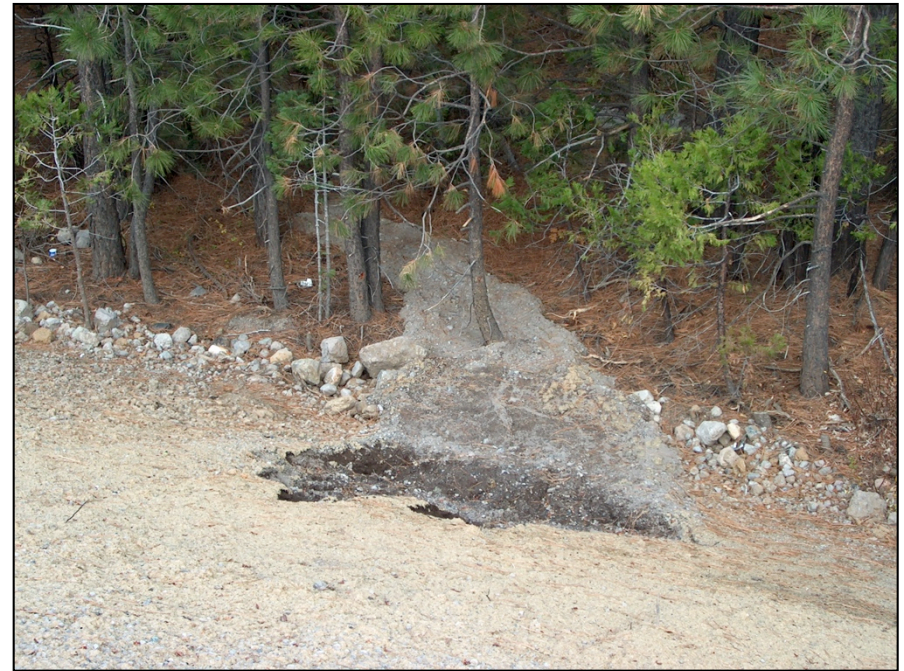
Site Challenges

1.5:1 slope: Debris flow at base of fill due to surface infiltration in coarse-grained material after first heavy rain. Very loose outer fill material, no track walking.

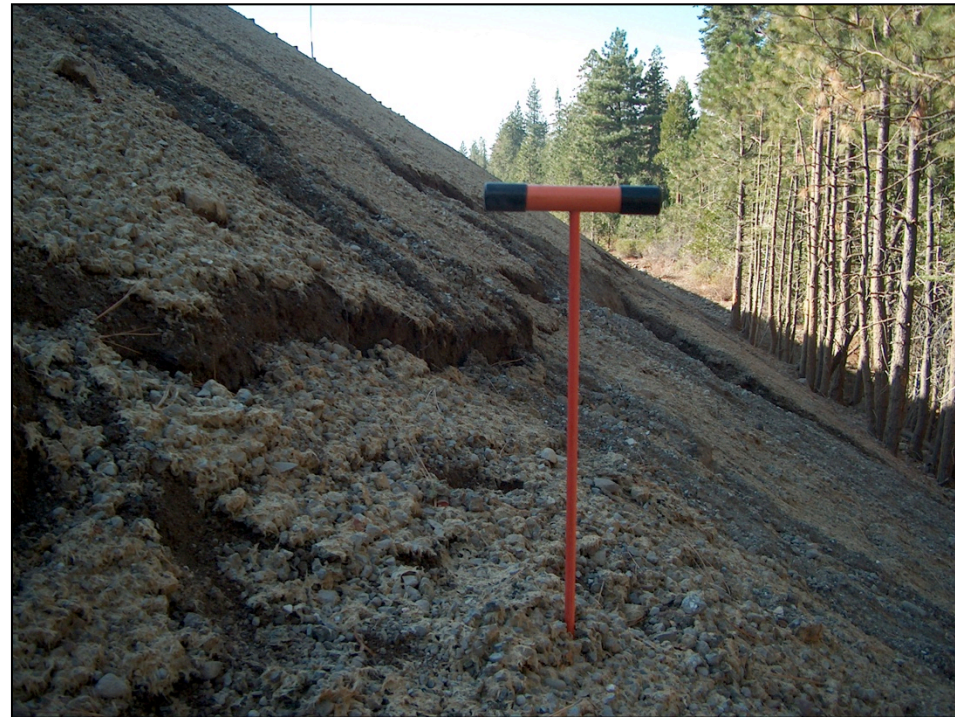
Site Challenges

Same location as previous slide, prior to complete failure of outer slope. Very loose to 3-foot depth, based on probe penetration.

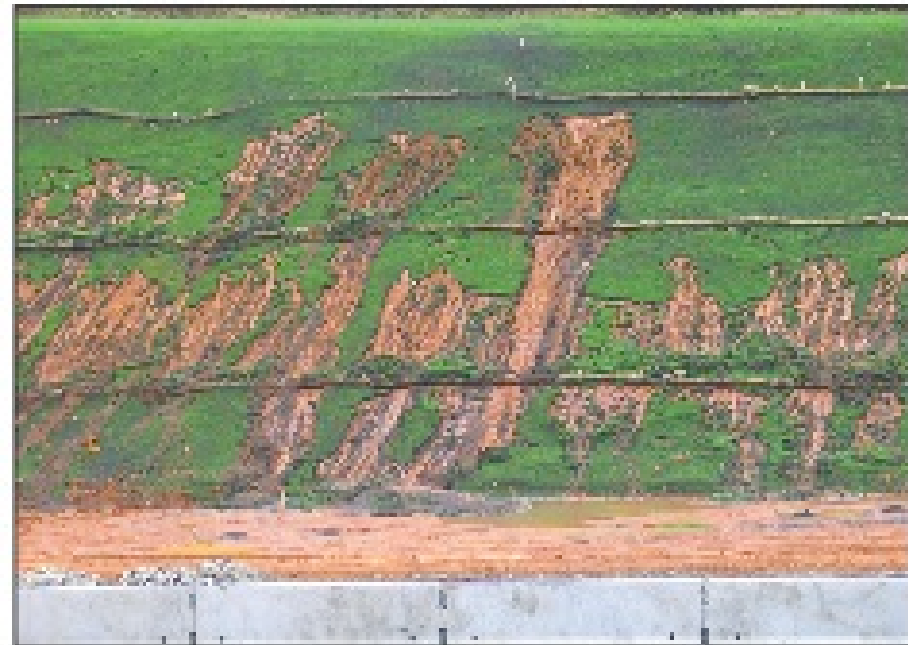
Figure 5.57 - In this photograph, a restrictive layer is very close to the soil surface. During a rain storm, water moved through the shallow soil layer and encountered a restrictive layer. Water then moved downslope, building up pressure, until the increased pore pressure and soil weight exceeded the strength of the soil to resist these forces. At this point, mid to lower slopes failed.

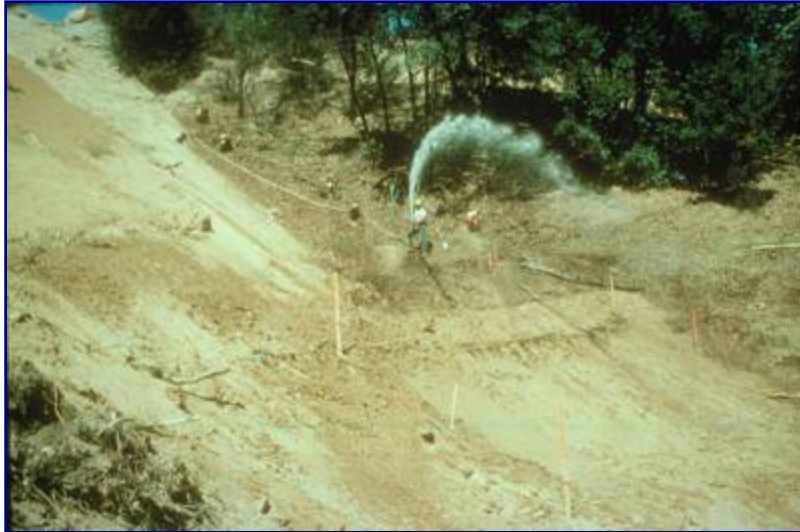
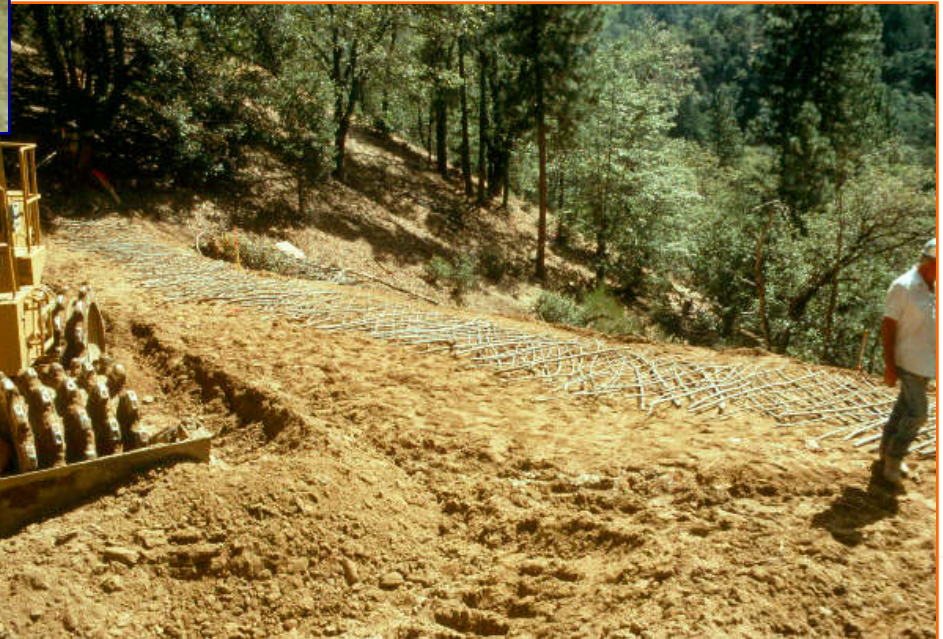
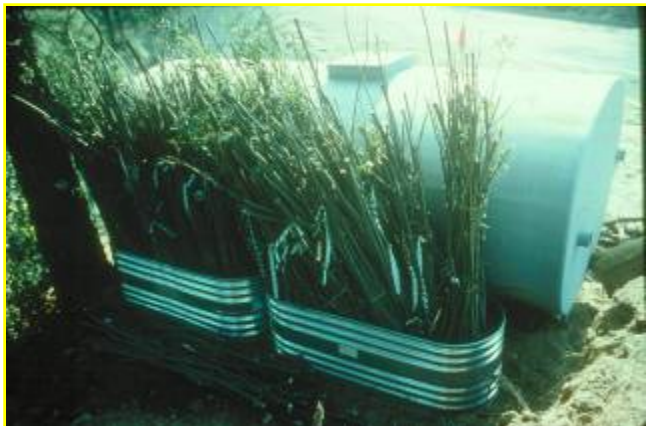
- Brushlayering was installed in September.
- Temperatures were over 100°
- Branches were not soaked (5-10 days current recommendation)
- Watering fill for compaction probably aided survival

- Installed in September.
- Temperatures over 100°
- Branches were not soaked (5-10 days current recommendation)
- Watering aided survival

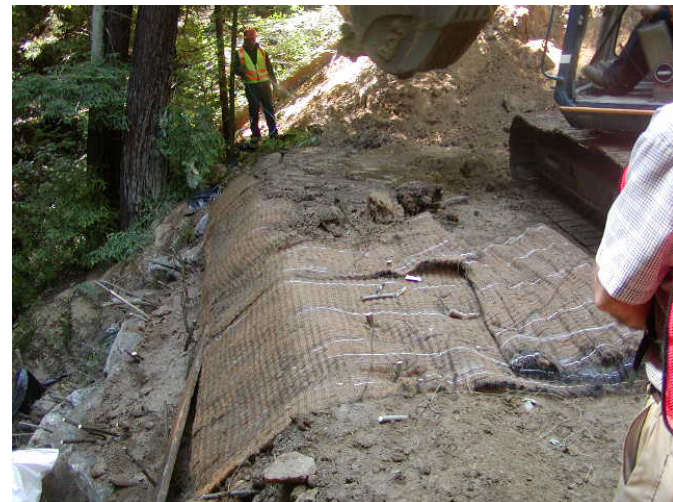
RECP Wrap – Case Study

- Slope failure of road fill
- A “coconut composite” *
TRM was selected for reinforcement and wrap
- * 3-layers high tensile,
permanent polypropylene with
biodegradable coir “filler” to
hold moisture for seeds

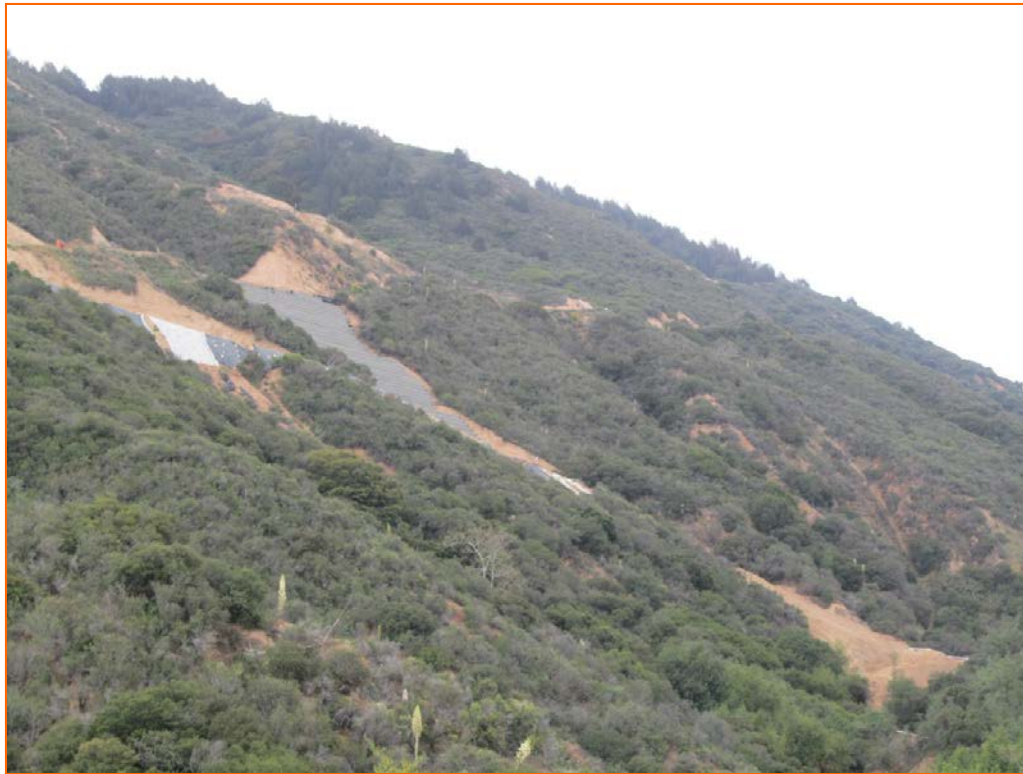
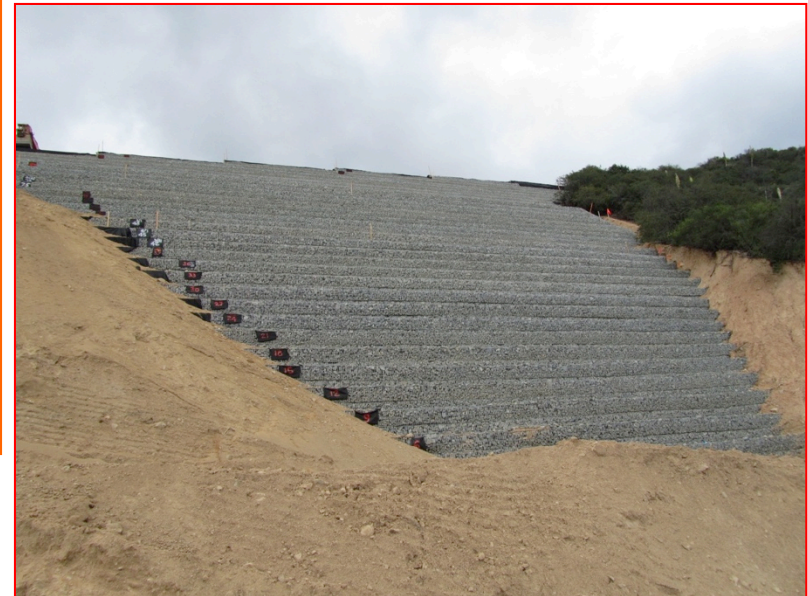
Hwy 330 – San Bernardino

RECP Wrap – Case Study – Wire Mesh Reinforced section (upper) and Soil Flap Section (lower)

- Estimated 60K CY failed, SKANSKA removed 15K CY.

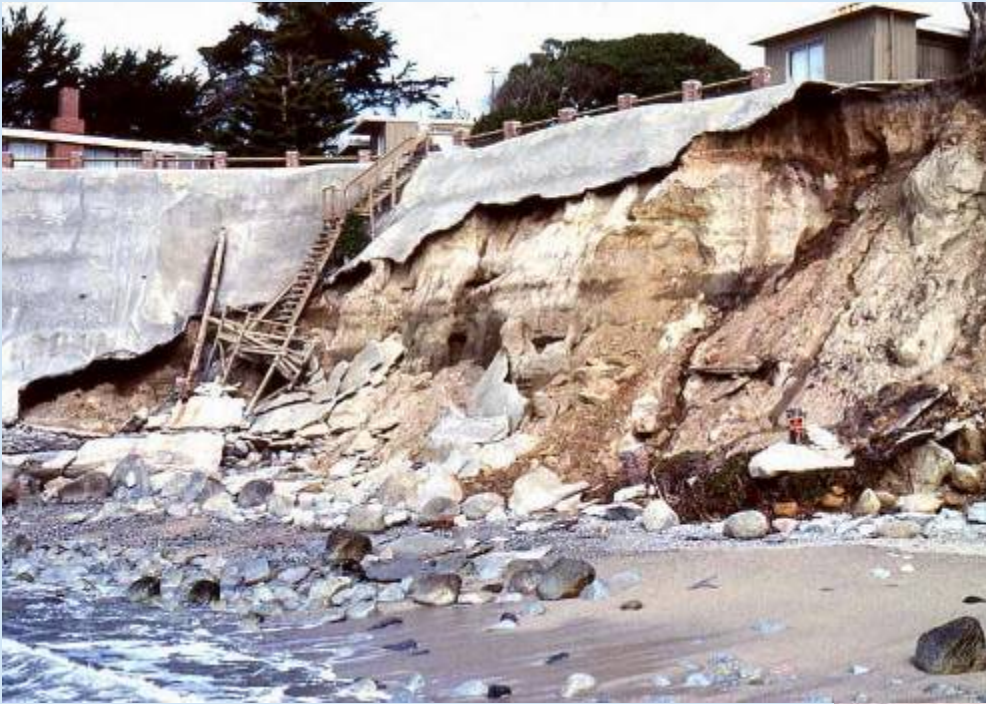
How Not to Repair Coastal Bluff

<---failed concrete (gunnite)
protective curtain

Curtain was blown out as a result
of unrelieved pore-water pressure
build up in bluff behind curtain

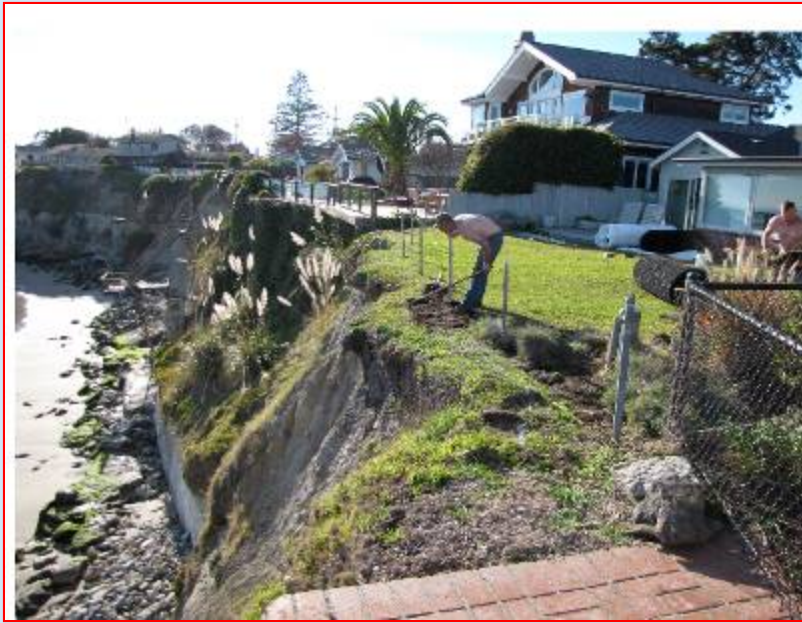
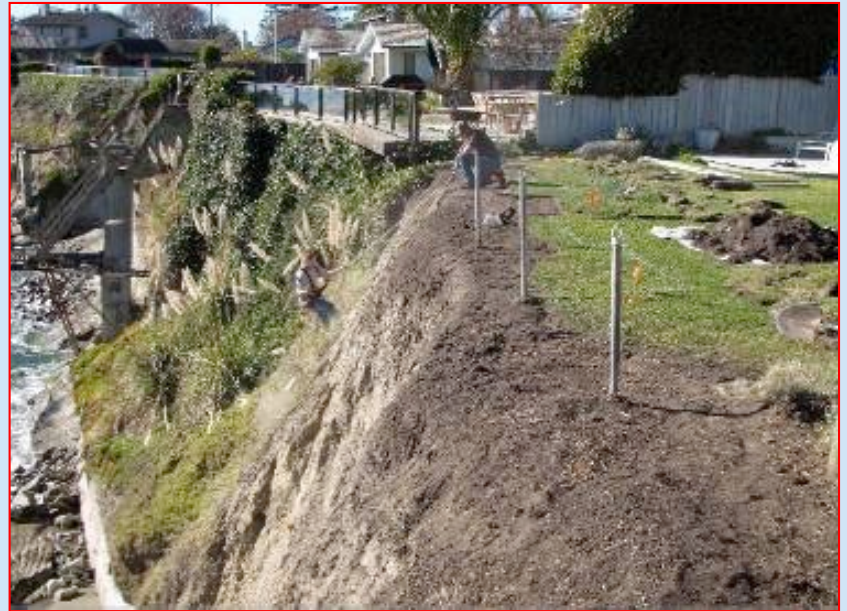
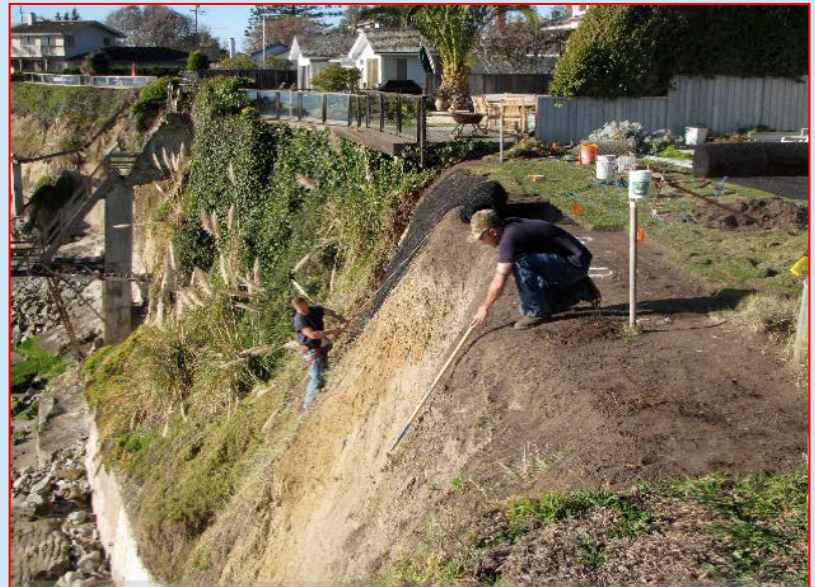
Bluff Repair Sequence

Preparing to install (drape)
Enka mat over bluff face

Enka Mat anchored 1' oc

Anchoring (“nailing”) Enka mat to bluff face

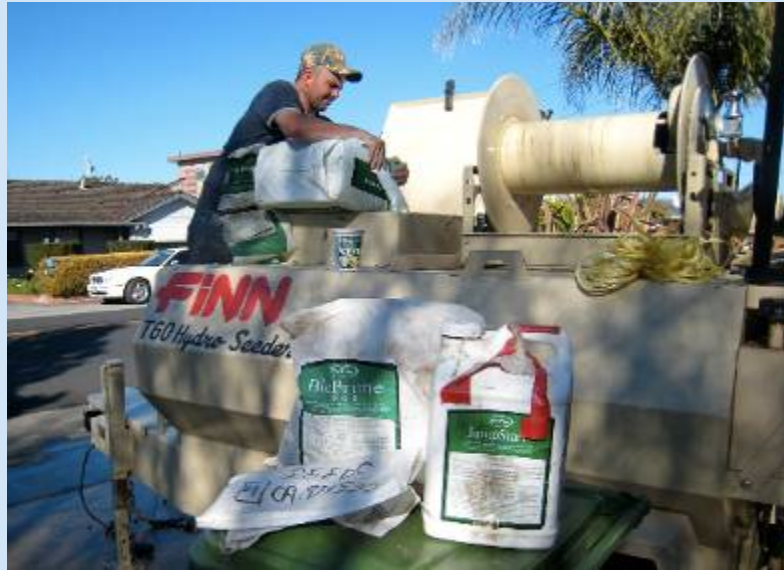
Bluff Repair Sequence (cont)

- Flexterra @ 4000# /ac
- Native Grass seeds (Maritime)
- Jumpstart (Profile) humic acid
- BioPrime (Profile) mychorrizeae,

Applying (spraying) hydroseed solution to bluff face ----->
